Guidelines for Rehabilitating Buildings  
at the Presidio of San Francisco

*Prepared by  
Architectural Resources Group  
San Francisco, California*

*for  
Presidio Project Office, Golden Gate National Recreation Area  
Denver Service Center  
National Park Service  
U. S. Department of the Interior*

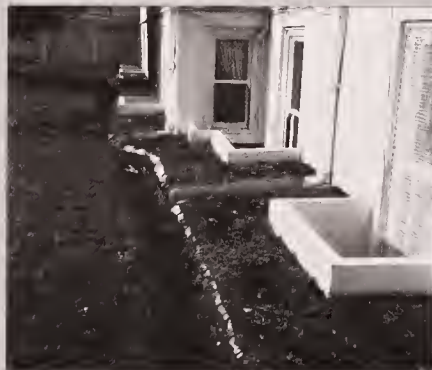
*Historic drainage systems are still in place beside historic buildings, roadways, and paths throughout the Presidio. They should always be considered before a new system is installed, and they should be rehabilitated for current use where possible, and maintained in place even if they have been superseded by newer drainage systems.*

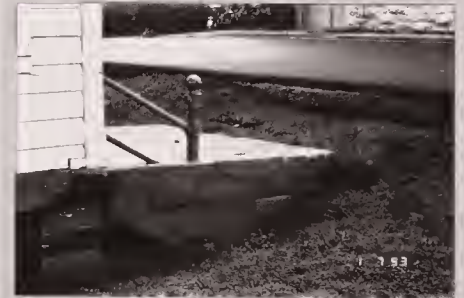
*Regrading for road improvements necessitated modification of the building entrance and adjacent site (as shown above). The work was poorly planned and executed, resulting in loss of the historic character of the building and the site and contributing to the physical deterioration of the property. Changes in grade affect drainage and circulation patterns and must be carefully planned.*

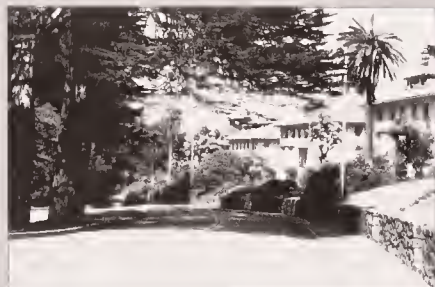
*Distinctive streetscapes are characteristic of much of the Presidio housing, which was designed to respond to the topography. The road parallels the natural contour and the similarly designed houses follow the curving road with a uniform setback. A stone retaining wall and regularly spaced trees define the edge of the road, and trees overhanging the roadway create a "ceiling."*

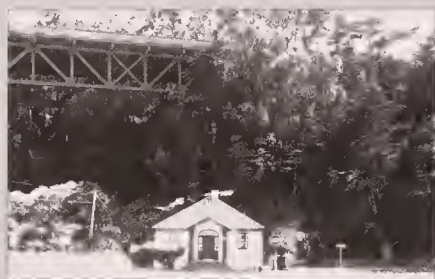
*Shown above is a vivid example of how an overscaled or elevated roadway can adversely affect the historic character of a site.*

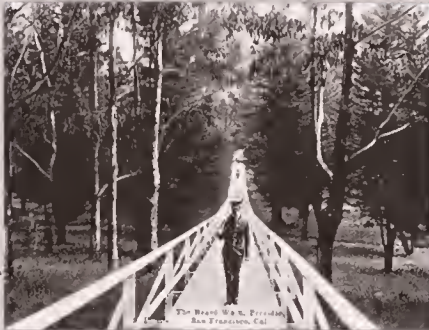
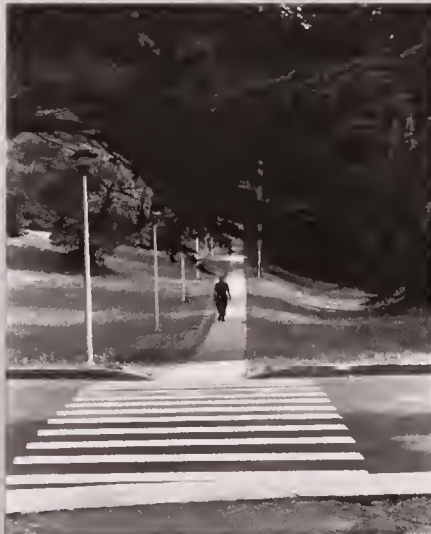
*Lovers Lane, which links the main post to the Presidio gate at the southeast entrance to the park, was once a formal boardwalk (above) but is now a paved path (below). This is an example of lost historic fabric.*

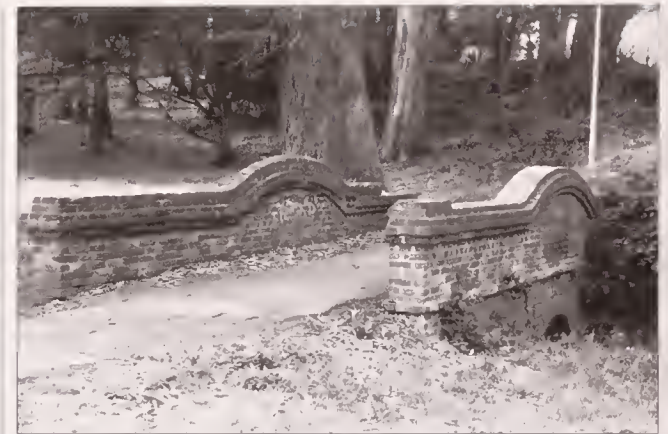
*The historic brick foot bridge (above) is located where Lovers Lane crosses Tennessee Hollow. Elements such as bridges, retaining walls, and curbs contribute to the character of a circulation system and should be protected. These elements are often jeopardized when roads or paths are resurfaced or widened.*

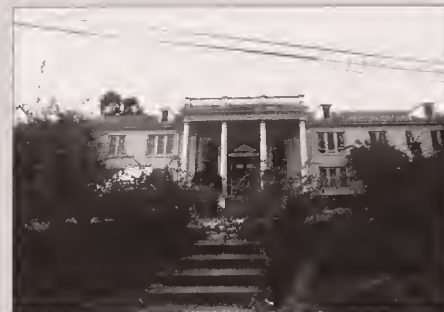
*Vegetation around and particularly in front of buildings at the Presidio is usually characterized by manicured, low planting that allows a clear view of the building from the street and clear sight lines from the building to distant views. Vegetation should be pruned regularly to maintain the historic sight lines. The area shown above has not been well maintained. Overgrown vegetation obscures the focal point of the building entry. It also creates a hazard for pedestrians and may lead to the deterioration of the stairs.*

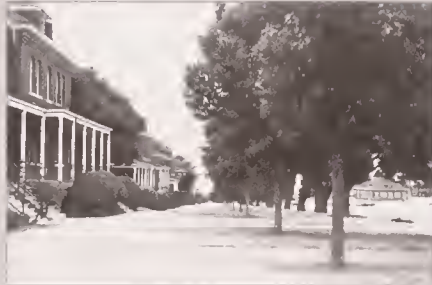
*Traditional military designs favored regular, linear arrangements. However, these replacement trees were planted in an alternative location, when the original location within the planting strip was both suitable and useable. These replacement plantings also block a character defining vista out to the bay.*

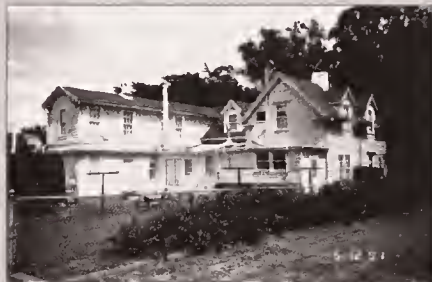
*In some situations, elements that divide the landscape along historically established boundaries are acceptable. However, they should be low or transparent so as not to change the perception of a site. In the example above, the fence and hedge are low enough that they do not obscure the views between buildings, yet they physically establish the boundaries between properties. The hedge softens the appearance of the chain link fence and improves its screening capacity.*

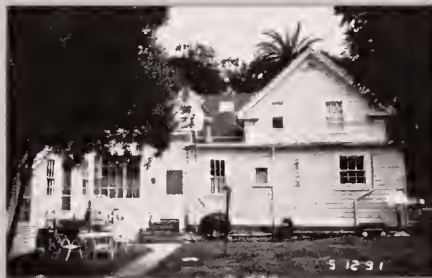
*The L-shaped plan of the historic residence above forms an “outdoor room,” at the rear, shielded against the prevailing wind. Site furnishings such as picnic tables, barbecues, and clotheslines, may be appropriate in such private spaces but should be moveable (as opposed to permanently installed). Storing such items indoors when they are not in use avoids general site clutter.*

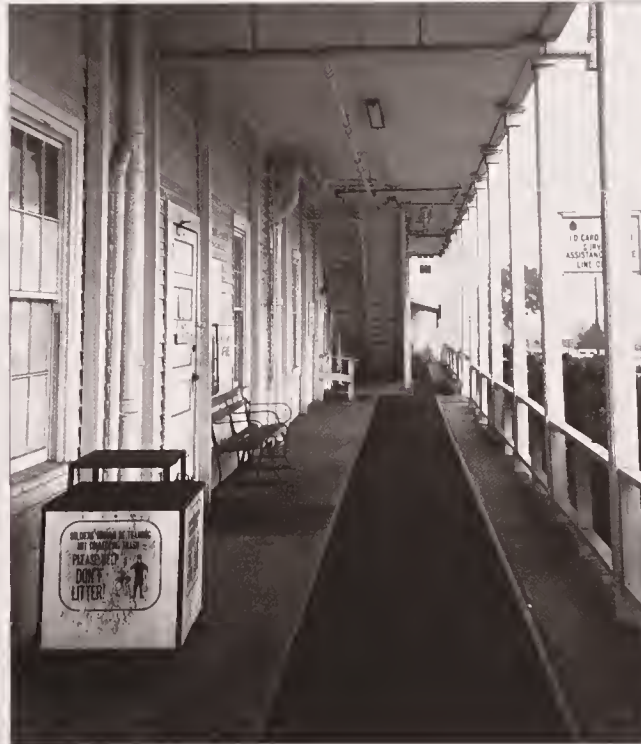
*Site furniture, such as benches, trash receptacles, picnic tables, and bicycle racks, should be carefully considered to ensure it is compatible in style, color, number, and size with the surrounding architecture and site. The placement, size, and design of the trash receptacle above make it an inappropriate choice for this location.*

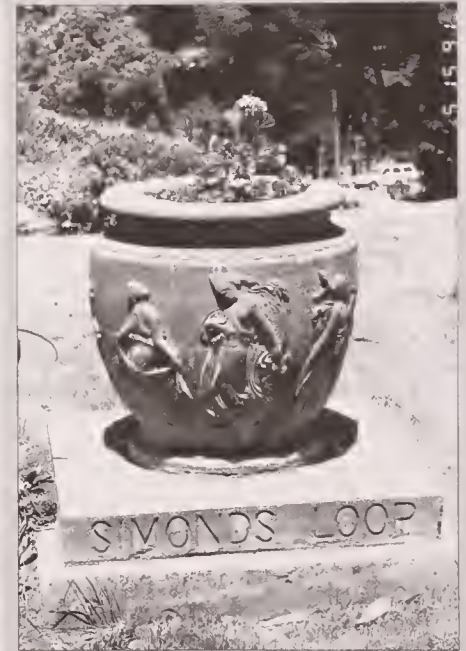
*Site objects having both aesthetic and functional purposes can be found throughout the Presidio. This decorative cast stone urn also functions as a street sign for Simonds Loop. Such objects should be identified and maintained in place. If they function as focal points in the landscape, views toward them should be kept clear.*

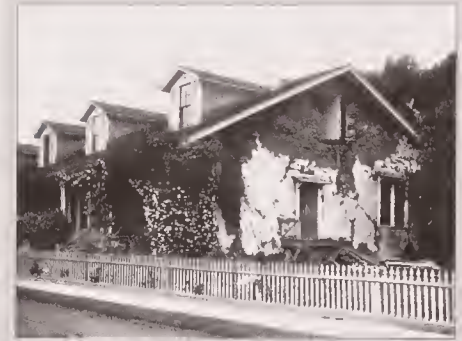
*This historic photograph from the 1906 album of General Greely shows an officer's quarters constructed of adobe at the Presidio. The only adobe now evident at the Presidio is within the wall of the current Officers' Club.*

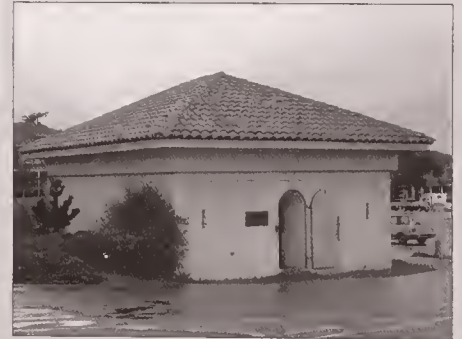
*A rare example of vaulted stone construction at the Presidio is the small 1863 powder magazine at the main parade ground.*

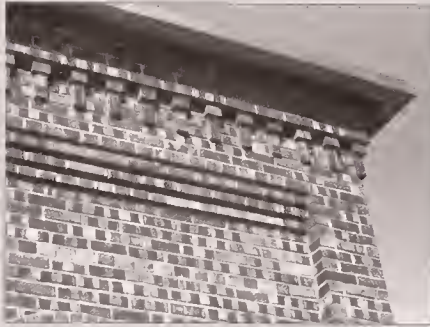
*Most of the brickwork found at the Presidio is laid in a common bond with a uniformly colored, dark-red brick. While decorative brickwork was not commonly used, examples can be found such as the corbelled and set-marked brick above.*

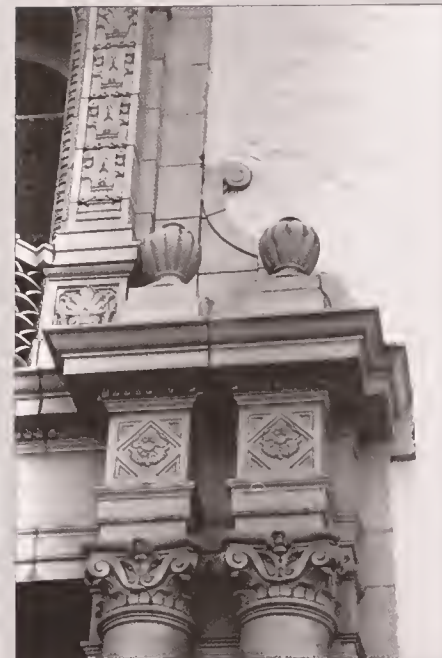
*Glazed terra cotta surrounds the entry of the main post chapel. Portions are covered with biological growth due in part to the condensation of moist air on the cool, relatively impervious, glazed surface. Biological growth can eventually damage the terra cotta and should be removed with water and a mild detergent. However, acidic cleaners are inappropriate because they will etch the glazed surface. There is a small plant that has taken root in the mortar joint. It should be removed and the joints repointed to prevent water from corroding the metal anchors that typically attach terra cotta to the structure.*

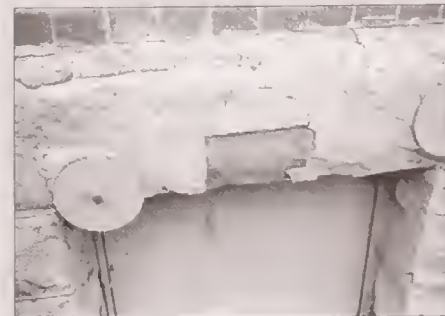
*Some of the brick and much of the sandstone at the Presidio have been painted. Because it is almost impossible to remove paint from masonry without causing damage, the best approach is to remove only loose and peeling paint to a sound surface and repaint with a breathable masonry coating.*

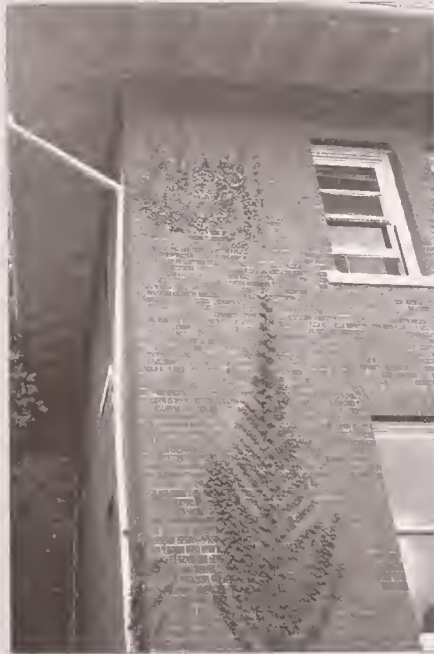
*Climbing ivy, though picturesque, is harmful to masonry. Besides holding moisture against the wall, its tendrils can penetrate mortar, causing deterioration and allowing moisture to penetrate the wall and the building.*

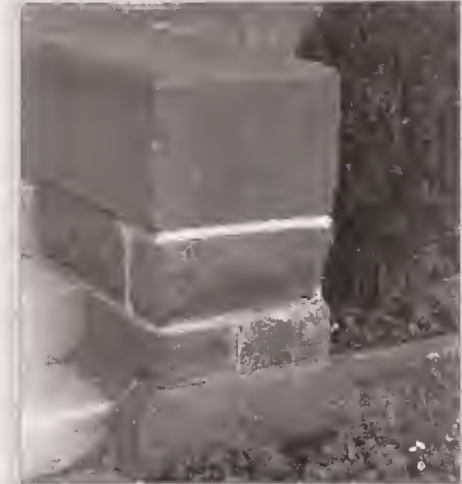
*The building detail above shows an example of inappropriate repointing, using a portland cement mortar that is too strong and dense for the stone and that does not match the original in color, joint width, or tooling.*

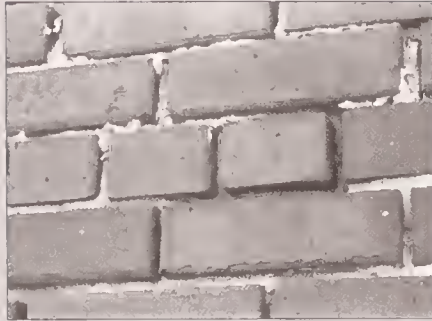
*Molded brick with deteriorated mortar joints is shown above. The impressions from the mold used in manufacturing is evident at the edges of these bricks. Any replacement bricks should match such details. Modern, machine-made brick is extruded and wire-cut, resulting in a sharper edge.*

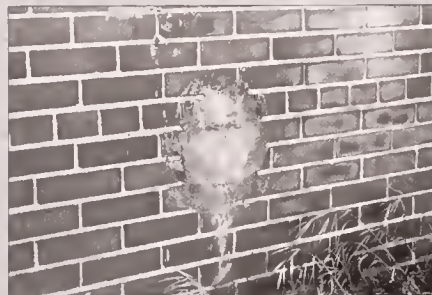
*The portland cement patch fills an earlier penetration. A more appropriate method would have been to fill the void with bricks and mortar that matched the original materials in color, size, composition, and tooling.*

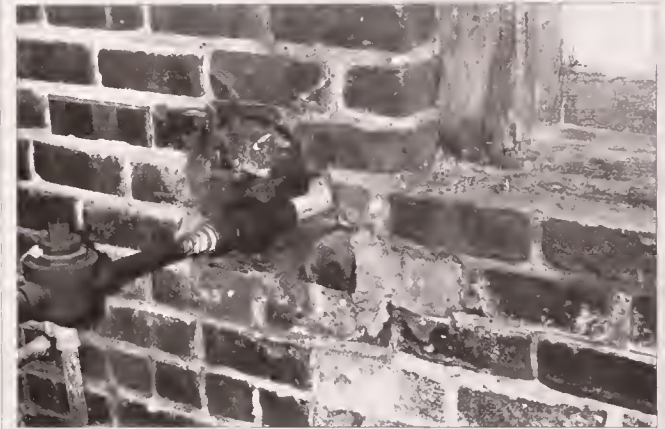
*In the past, penetrations in masonry walls were often made with little concern for historic fabric. When penetrations are necessary, they should be made by neatly core-drilling as small a hole as possible through the fewest number of masonry units and finally covering the penetration with an escutcheon.*

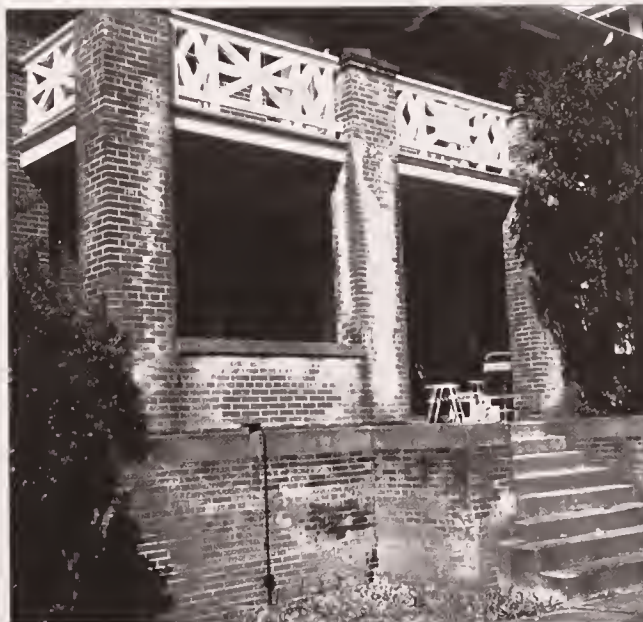
*Excess moisture in the wall has caused water-soluble salts to migrate to the surface of the brick. This white deposit, called efflorescence, can usually be removed by simply brushing or rinsing with a minimal amount of water. The pattern of efflorescence suggests that clogged or insufficient drainage at the second-story deck is causing rainwater to move through the masonry piers. The drainage system should be redesigned to direct excess water off the deck and away from the piers.*

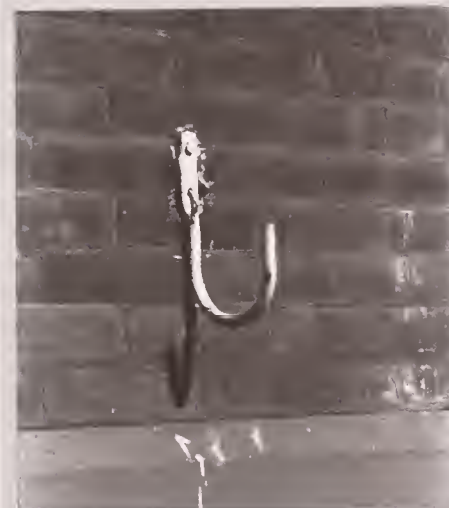
*If metal elements are attached to a masonry wall, they should be embedded into a mortar joint rather than into the masonry unit. When painting elements adjacent to masonry, carefully protect the masonry from paint spills.*

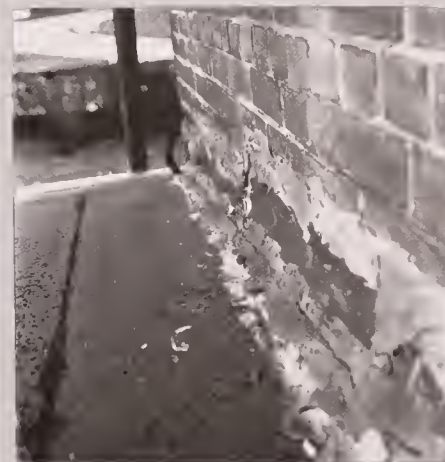
*Asphalt or bituminous waterproof coatings applied in the past are visually incompatible and can intensify damage to the masonry when moisture enters through cracks in the coating and cannot escape.*

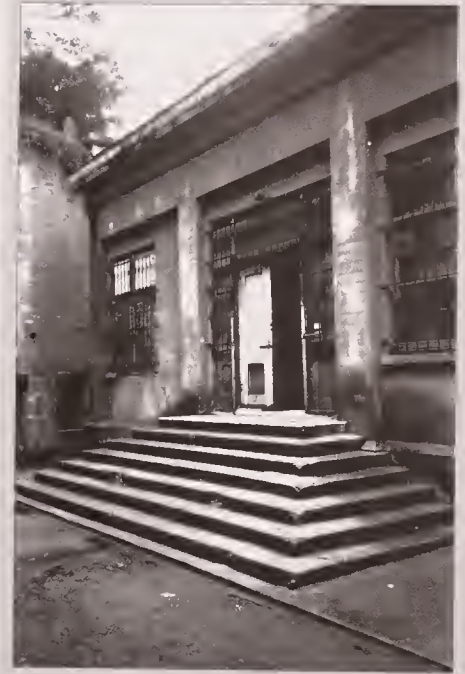
*Before 1906, only a handful of nationally known architectural firms designed concrete buildings. One of these was the San Francisco firm of Percy and Hamilton, which designed the Battery Dynamite Power House, built in 1895. This project may have been designed with Ernest L. Ransome, an important pioneer of reinforced concrete, who frequently collaborated with Percy and Hamilton on its reinforced concrete buildings.*

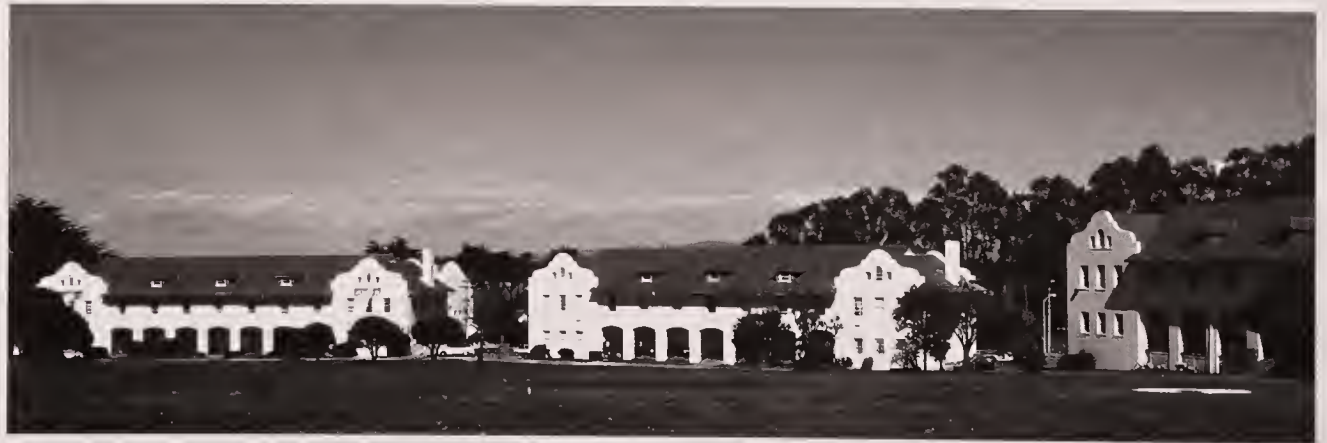
*Most concrete walls at the Presidio were coated with a cement stucco to inhibit moisture penetration, correct surface defects, and conform to a style, as in the Mission Revival buildings above.*

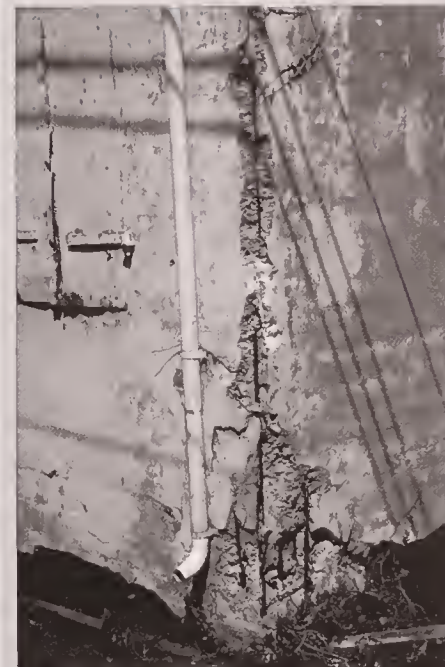
*A common design flaw in early concrete construction was insufficient protective concrete cover over reinforcing bars. Moisture can easily penetrate the light concrete cover and corrode the metal reinforcing bars.*

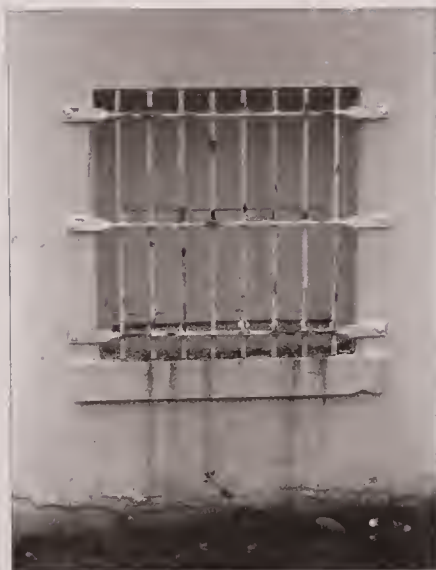
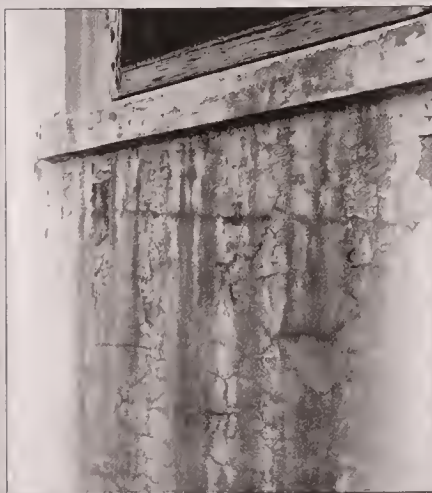
*Ferrous staining is shown above, and biological growth is shown below. The surface should be cleaned only when necessary to halt deterioration, always using the gentlest method possible.*

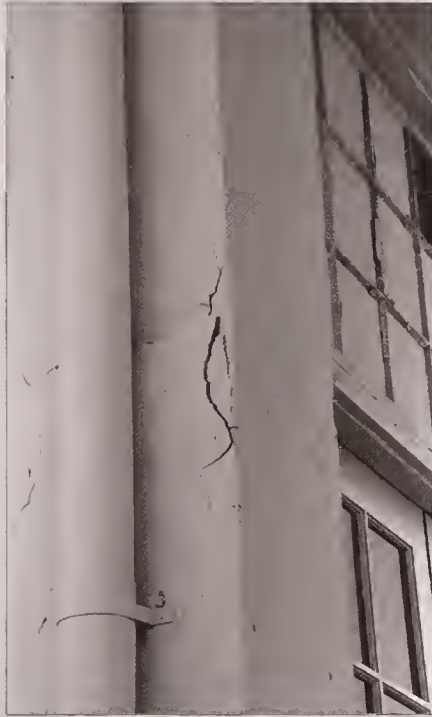
*Cracks, buckling concrete, and spalls indicate underlying deterioration, such as uneven settlement, illustrated at lower right, and corrosion of embedded reinforcing bars, illustrated above and at upper right. Corrosion can produce tremendous expansive forces, causing the surrounding concrete to rupture. Once initiated, corrosion of reinforcing bars will continue unless the steel is cleaned back to bright metal and immediately coated.*

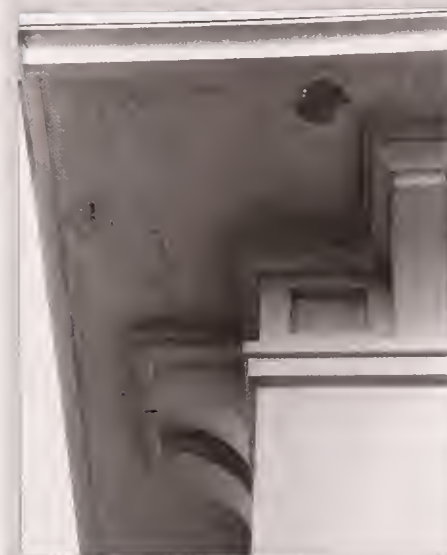
*The building detail above shows evidence of damage due to moisture migration under eaves. Drip grooves may need to be added at the underside of overhanging eaves, edges of sills, belt courses, or projecting slabs if the original detailing was deficient and contributes to moisture retention and subsequent deterioration.*

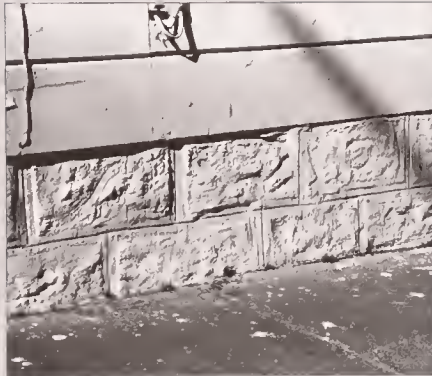
*Early concrete was sometimes finished with a thick layer of cement paste worked to resemble stone.*

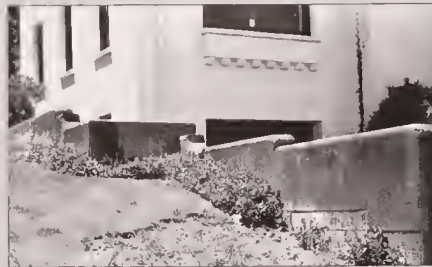
*Surviving concrete site work such as retaining walls and steps should be maintained, stabilized, and repaired.*

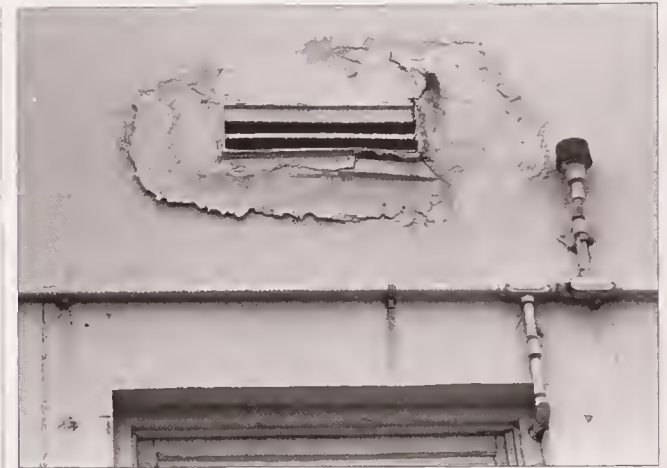
*Patching concrete without first correcting the source of deterioration will result in failure of the repair, as in the building detail above. Previous patches that do not match the texture or color of the original wall surface should be removed and replaced with material duplicating the original mix in composition, strength, color, and surface texture.*

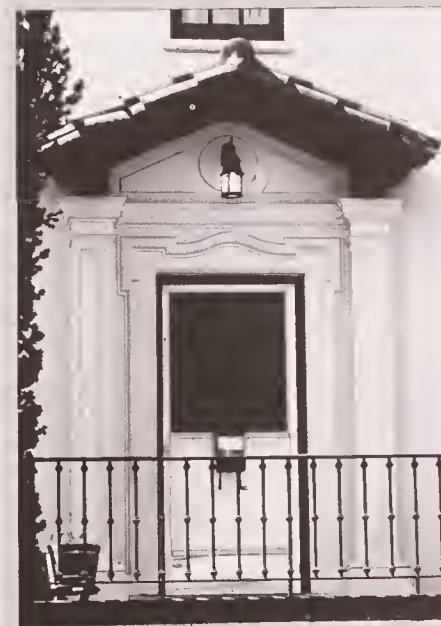
*Cast concrete, such as the door surround above, sometimes replicated stone by incorporating stone fragments or mineral pigments into the original mix. Any repair should reproduce the original mix even if at present the feature is covered with paint or stucco.*

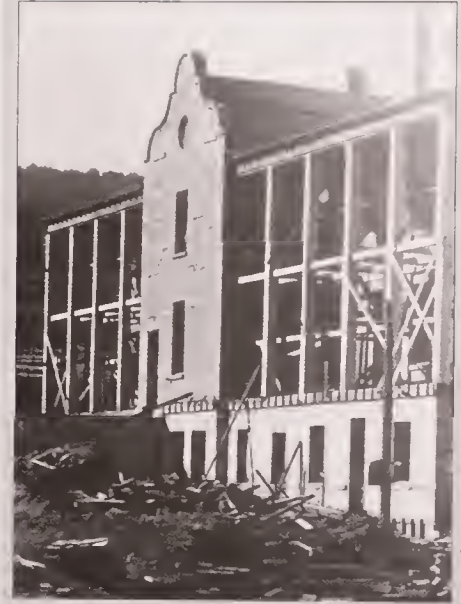
*A cement stucco coating has been applied to some masonry buildings at the Presidio to improve their water-shedding capacity or for stylistic reasons. The Mission Revival style Stillwell Hall was built of reinforced concrete and brick, but was always covered by a unifying light-colored cement stucco.*

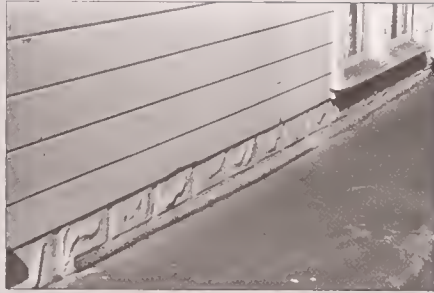
*Although most stucco at the Presidio has a smooth troweled finish, some stucco, as in the examples on this page, has been worked to imitate plaster over rubble masonry or dressed stone.*

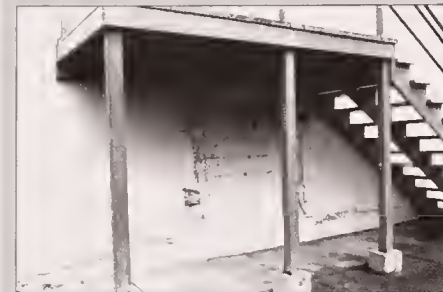
*A stucco finish was often applied to cover surface defects.*

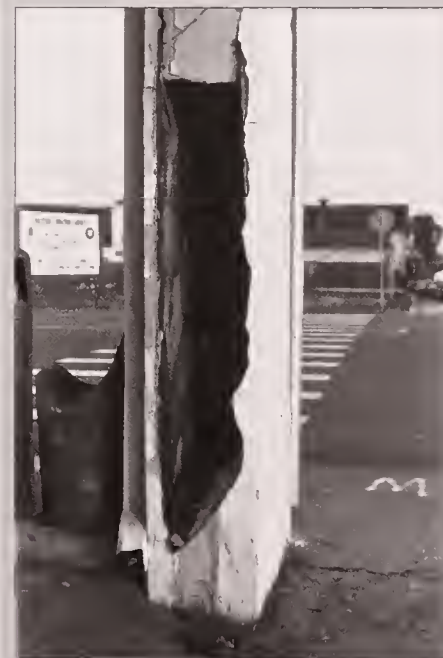
*Stucco can mask serious problems in the substrate until well after damage has occurred. In the example above, stucco covered ongoing fungal rot due to water infiltration in the wood structure.*

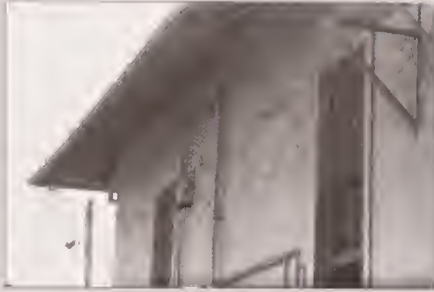
*Textured stucco provides ledges where airborne dirt collects. Dirt can be gently brushed off or rinsed with low-pressure water cleaning. Chemical cleaning should be undertaken only if the dirt is causing deterioration. The gentlest cleaning method should be determined and tested. It is difficult to clean most stucco without losing some surface texture.*

Clean stucco only when necessary to halt deterioration or remove heavy soiling. It is difficult to clean most stucco without also removing some of the textured surface.

Remove soiling and biological growth, such as mold, using a low-pressure water rinse and mild detergent applied with natural fiber brushes. Poultice-applied solvents are probably the most appropriate method for removing graffiti and metallic stains.

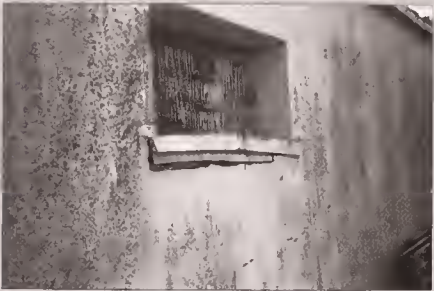
*Biological growth is generally an indication of more serious problems that have led to moisture retention in the wall. The basic problem must be remedied before stucco is repaired and cleaned.*

Survey stucco surfaces for conditions such as biological growth, water or metallic staining, or leaching deposits, which may indicate active water penetration or damage that is masked by the stucco coat.

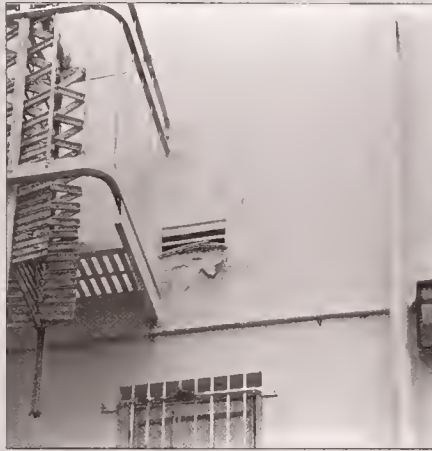
*Previous patches that do not match the texture, color, or strength of the original stucco should be removed. Stucco patches were often applied without first remedying the underlying problem, which leads to failure of the new patches.*

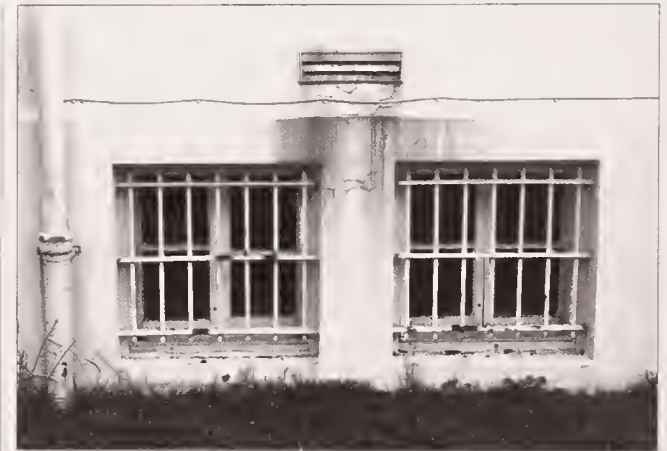
*Metallic stains from copper or iron penetrate deeply into stucco and are difficult to remove. The safest and most effective removal technique is the application of appropriate solvents using poultices.*

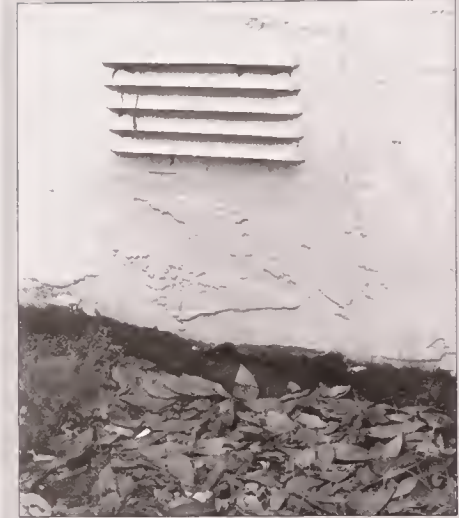
*Surface runoff should be directed away from the base of a stuccoed building. Unless contact with the ground and plant material is prevented, moisture will rise through the stucco and into the substrate.*

Applying stucco without providing adequate separation from the ground. Moisture from the ground can rise through the stucco and into the supporting structure.

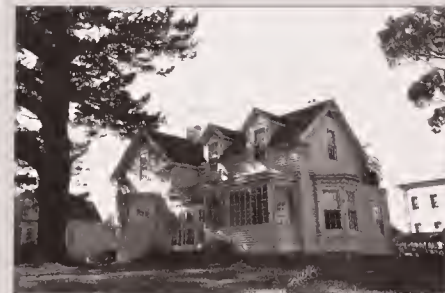
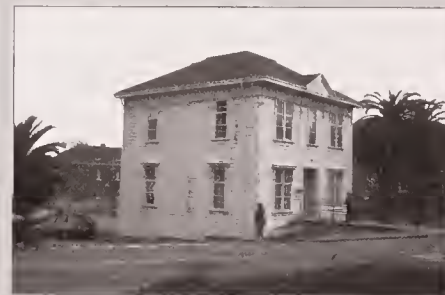
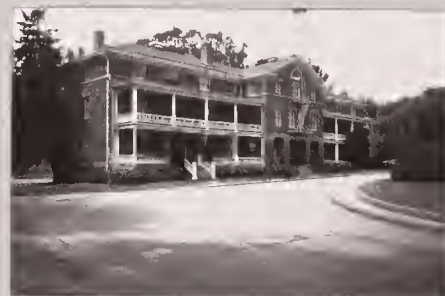
*The Presidio has a number of historic wood buildings. Wood is also a substantial part of both the interiors and exteriors of many masonry buildings, such as the wood porches and cornice on the brick and stone building immediately above.*

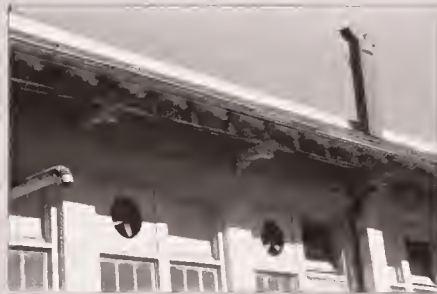
*Exposed rafter ends are character-defining features of many Presidio buildings. Wood in this position is especially vulnerable to fungal rot and attack by insects, because the endgrain of the wood—which is softer and readily absorbs water—is exposed.*

Apply environmentally safe chemical preservatives to wood features, such as beam ends or outriggers, that are exposed to decay hazards and are traditionally unpainted.

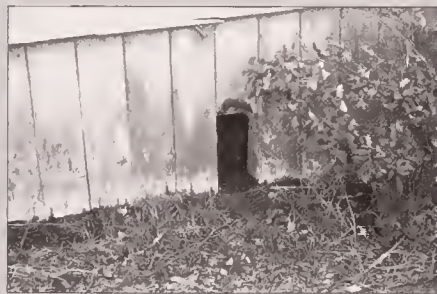
*A common design flaw in wood buildings at the Presidio is inadequate separation from the ground. Moisture seeps through the wood member and into the structure. This makes a building susceptible to attack by insects and fungi and to damage by rodents and other small animals.*

Moisture, usually in combination with other influences such as insects and fungi, weakens the structure of wood and is the main cause of wood deterioration. Common design flaws in many of the wood buildings, especially the temporary buildings, are inadequate separation from the soil and insufficient drainage. These conditions allow moisture to migrate through wood foundations and spread to the main structure.

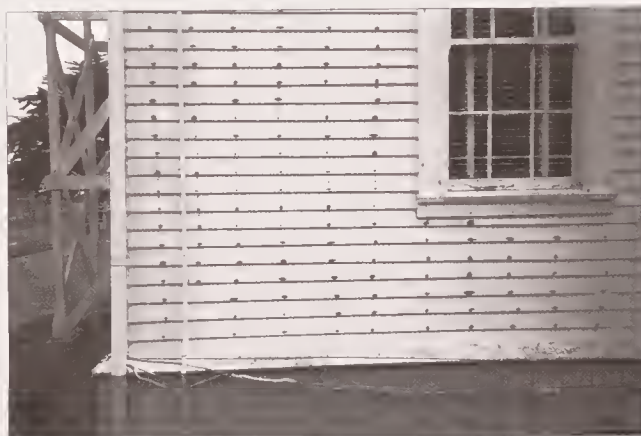
*An example of biological staining is shown above, and metallic stains from corroding steel nails are shown at upper left. Countersunk galvanized nails, with a wood filler applied over the heads of the nails, or stainless-steel nails should be used to avoid metallic stains. Gentle cleaning with a low-pressure water rinse and mild detergent applied with a soft bristle brush should remove biological growth.*

Using nongalvanized fasteners in moist conditions. These can discolor and chemically attack certain woods, including redwood, Douglas fir, and oak.

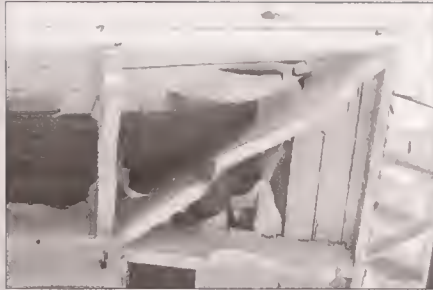
*Peeling paint in large areas usually indicates more serious problems. In this case, a deteriorated roof or missing gutters are likely causes of the deterioration.*

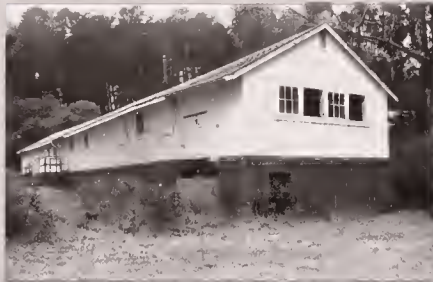
*Foundation skirts of spaced vertical boards allow air to circulate through the crawl space, ventilating the foundation. Good ventilation is the key to preventing rot in wood members exposed to moisture.*

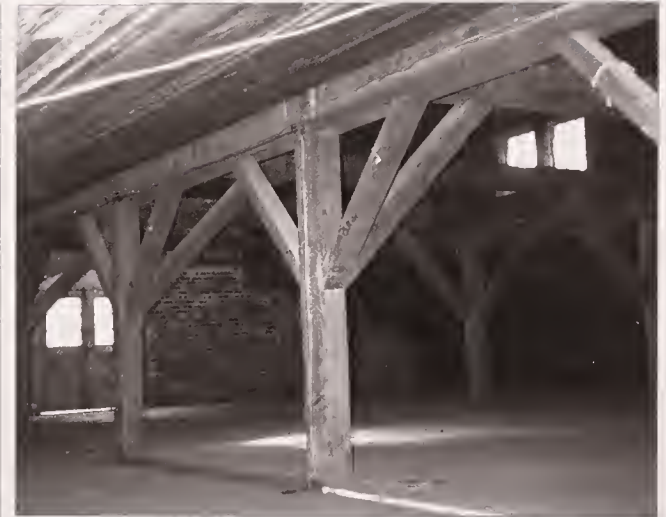
*Rough-sawn unpainted posts and finishes in the warehouses and stables are important character-defining elements of these interiors. Mechanical loading equipment has damaged historic floorboards and posts. The historic fabric must be adequately protected from future damage.*

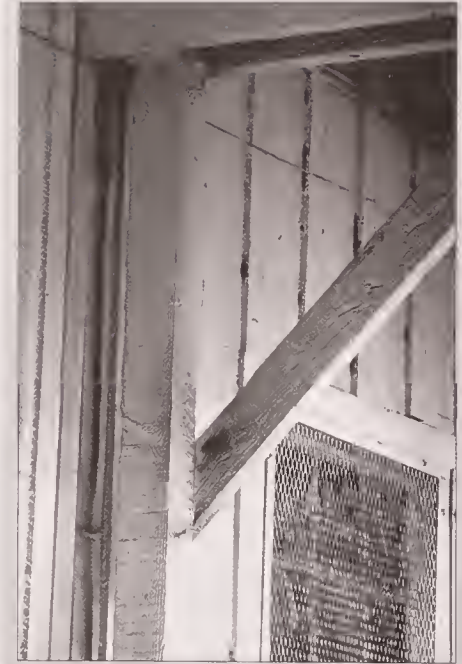
*Paint is an effective means of keeping wood dry. The protective coating must be maintained, but unnecessary painting should be avoided. Sometimes the more exposed facade of a building, similar to that illustrated at left, can be painted more frequently than the entire structure. This will avoid unnecessary paint buildup on other facades, which can dull the wood's texture. Surface texture, like the rough-sawn lumber pictured above, is a significant part of the character of wood and should not be obscured.*

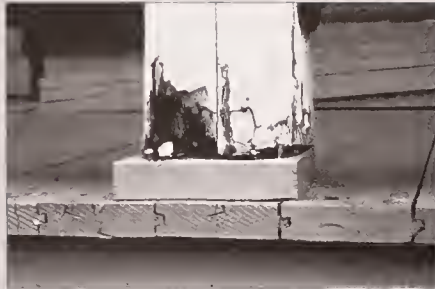
*Column bases are particularly vulnerable to rot, because the endgrain of the wood is exposed to moist conditions and rot in the wood decking can easily spread to the column. The drawing below illustrates a good detail characteristic of some Presidio buildings. A metal base is designed to allow ventilation between the decking and the column base, interrupting the path of moisture and isolating columns from the deck.*

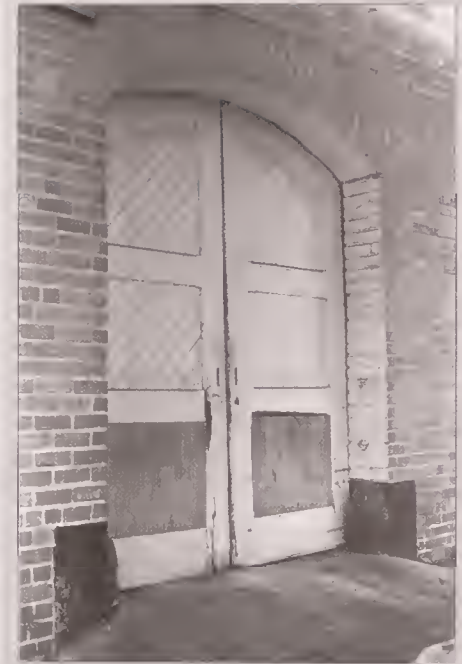
*Wooden doors are common at the Presidio and are often character-defining features. They are vulnerable to vandalism, impact damage, and moisture, but should be maintained and conserved rather than replaced.*

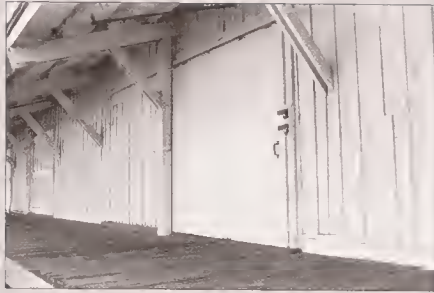
*The plywood door pictured above replaced an original board-and-batten door. Replacement in kind, if the original could not be conserved, is a more appropriate design solution.*

Replacing milled lumber with plywood. Plywood is both historically inappropriate and visually distinct from historic wood.

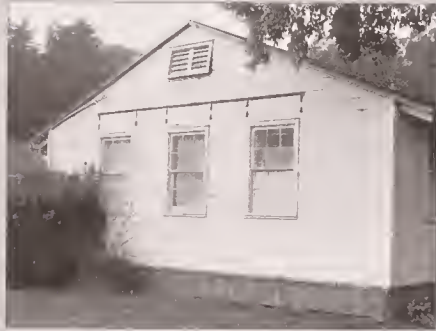
*Missing paint in the photo above indicates the removal of a pent roof that once shaded the windows from direct sunlight and guided rainwater from the openings. Missing elements such as this should be replaced if there is sufficient documentation to aid in their reconstruction.*

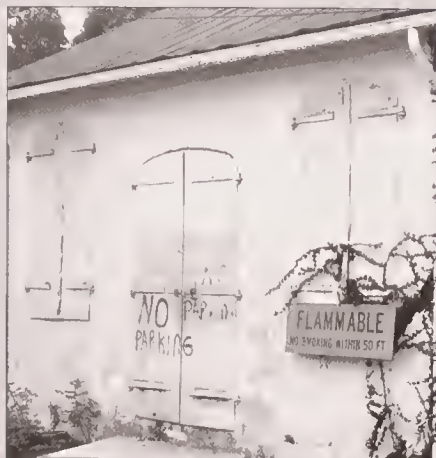
*Iron shutters over window and door openings provided fire protection for early masonry warehouses.*

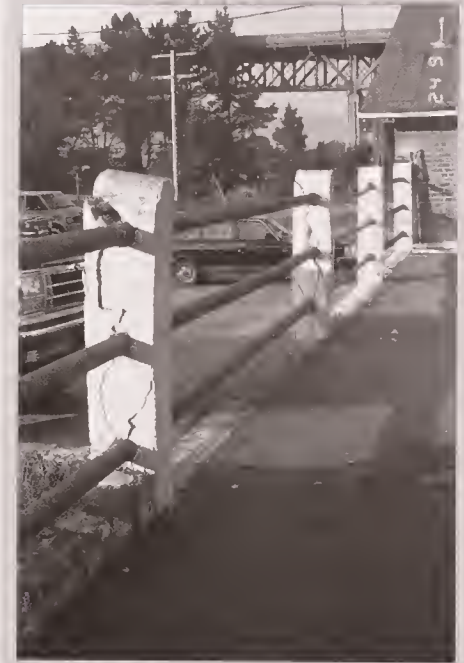
*As metal corrodes, it expands in volume and exerts tremendous pressure on the surrounding material. Here, corrosion of the metal rails and embedded reinforcing bars has split the concrete posts.*

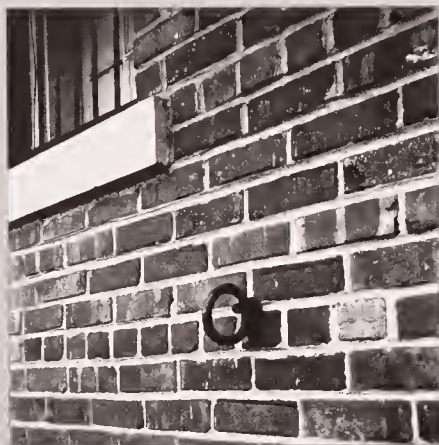
*Although most architectural metal at the Presidio was mass-produced, there are some handwrought elements like this wrought iron hitching ring on the exterior of a stable. Wrought iron is somewhat more resistant to corrosion than other ferrous metals, and it has not always been historically coated. To minimize potential damage to surrounding masonry, metal elements should be attached through a mortar joint as above rather than through a masonry unit.*

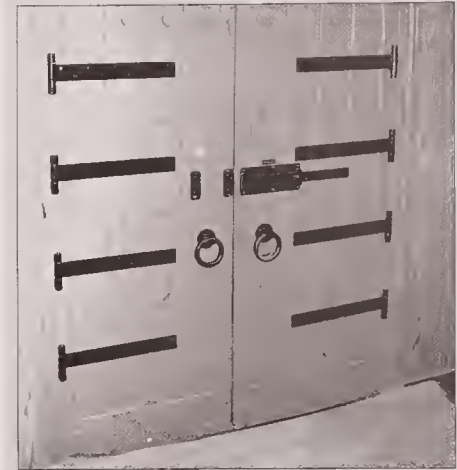
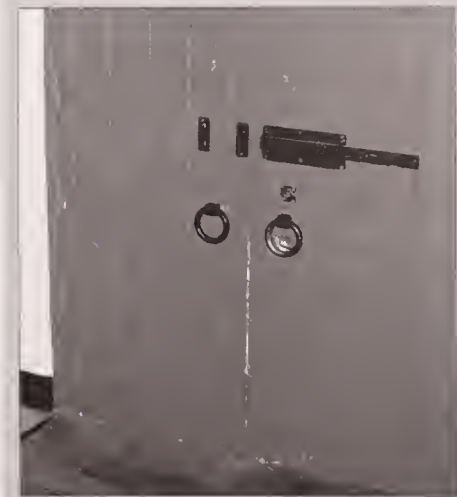
*Character-defining hardware has often been removed and replaced with inappropriate substitutes. The original hinges and door pulls on these historic doors were intentionally overscaled and made of a ferrous metal, painted black, consistent with the Mission Revival and Mediterranean Revival styles. The historical character of the door at the lower right has been diminished by painting the original hardware the same color as the door.*

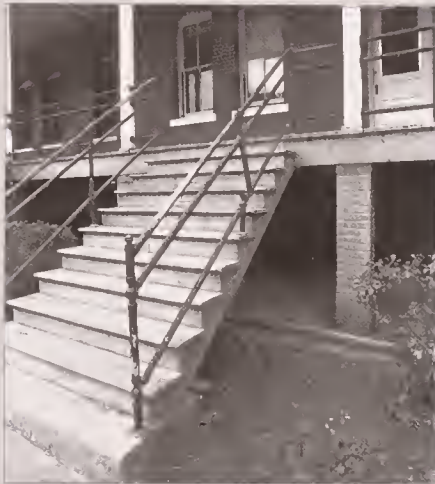
*Metal elements are often made of separate pieces bolted or screwed together. A joint in the post shown above has failed, dangerously weakening the railing and allowing water to collect in the pipe, eventually leading to corrosion from within.*

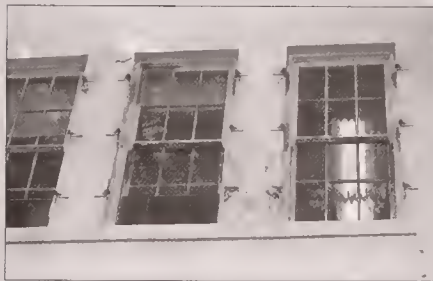
*Fragments of historic metal elements such as these mounts for iron window bars, must be retained in place and maintained. If allowed to corrode, they will split the masonry.*

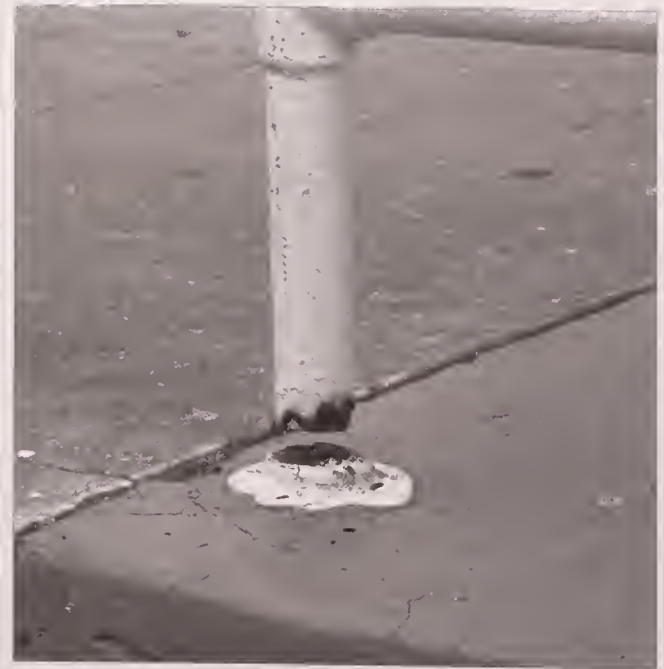
*The base of the post shown at right has completely corroded due to pooling water inside the pipe.*

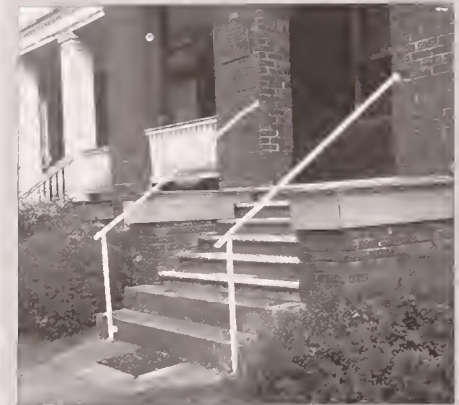
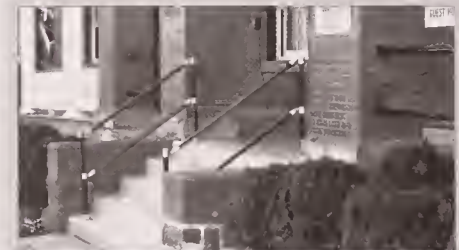
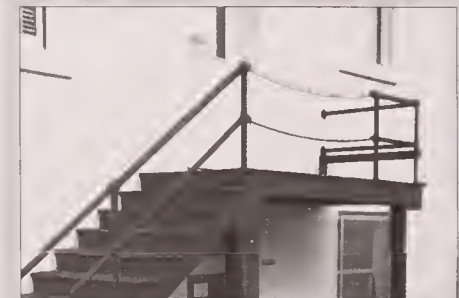
*The replacement rails illustrated above are either hazardous or inappropriate because of color, pipe diameter, or joint detail. In these examples, a round pipe rail consistent with those of the historic period and painted black would have been a more appropriate choice.*

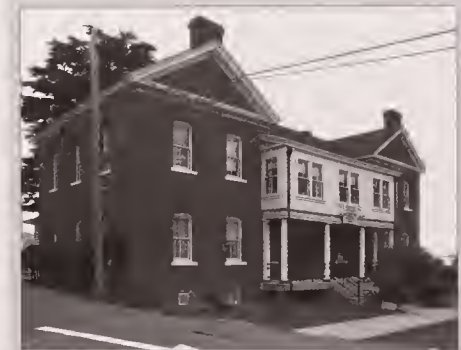
*This late 19th-century building exhibits the restrained classical detailing of many Presidio buildings. The roofing originally may have been slate, but with its later composition shingles, it has become part of the dominant red roofscape.*

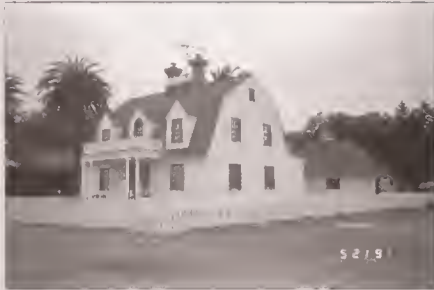
*Examples of several unique Presidio roof forms appear in the building above: the gambrel roof of the main house and the flared hipped roof with the cupola on the garage. Antennas are often unfortunate but removable additions. Placement of such equipment must be carefully planned.*

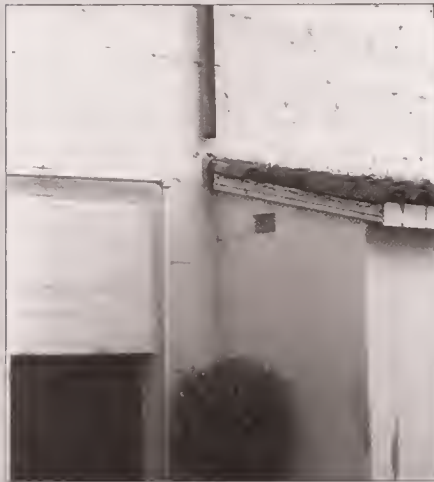
*Gutters and downspouts provide an integral function of a roof. Lack of attention to these elements, as seen here, greatly contributes to building deterioration.*

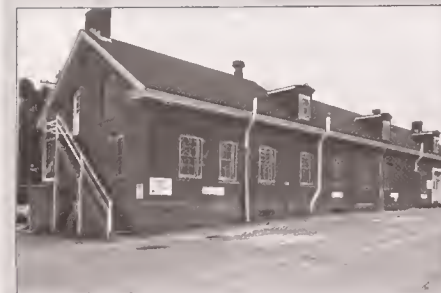
*The roof on this building has many elements that combine to give it character; the red shingled surface; the dormers, chimneys, and ventilators; and the cornice detail at the gable end are all significant features. Relatively unobtrusive skylights have been added.*

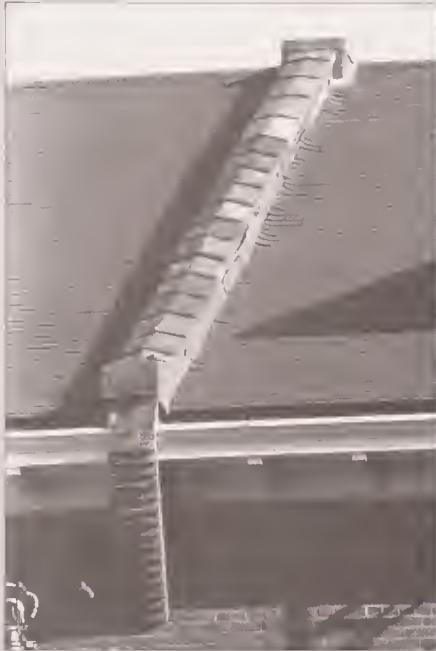
*When this roof was changed from slate to composition shingles, the terra cotta coping on its firewalls was retained. Significant features such as these should always be preserved when roof work is undertaken.*

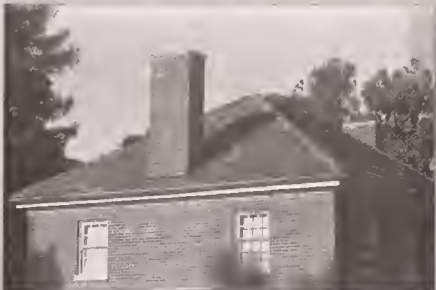
*This tall chimney has been strapped as a stabilizing measure, but further strengthening will be required for seismic safety.*

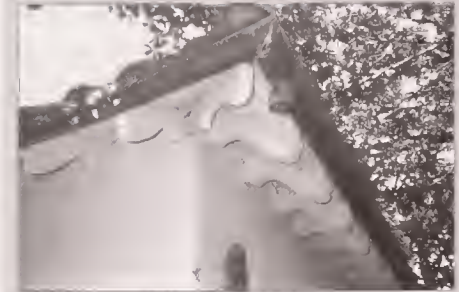
*The eaves under this roof exhibit several common problems: accumulation of debris in gutters, a deteriorated gutter, and missing downspout. Poor roof and gutter maintenance has probably caused damage to the wood and stucco surfaces and perhaps to the structure as well.*

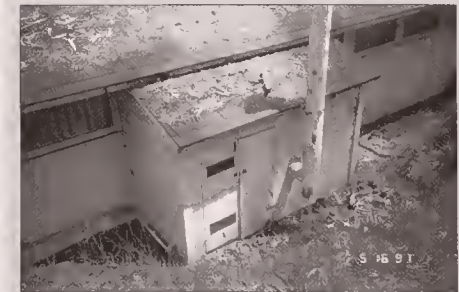
*The leaves lying on this roof will retain moisture and damage the roof.*

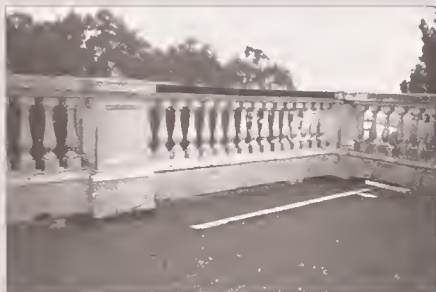
*Built-up roofs at the Presidio are generally newer, except for porch and portico roofs such as this one. Lack of maintenance of the wood balustrade has resulted in loss of material and water penetration, and may have damaged interior spaces.*
